Technical Evaluation of the Gold King Mine Incident

San Juan County, Colorado

U.S. Department of the Interior
Bureau of Reclamation
Technical Service Center
Denver, Colorado

October 2015

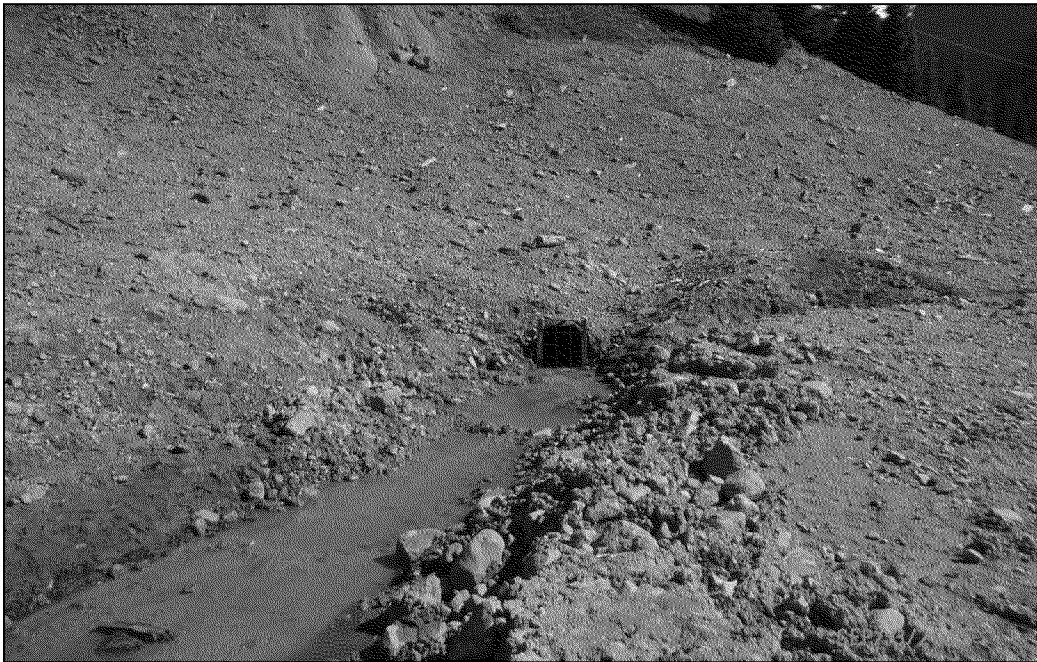
Figure 7.—Photograph showing the seepage outflow from the drain pipe at the American Tunnel at Gladstone, Colorado, as it appeared on September 3, 2015, with about 100 gpm of acid water flowing out.

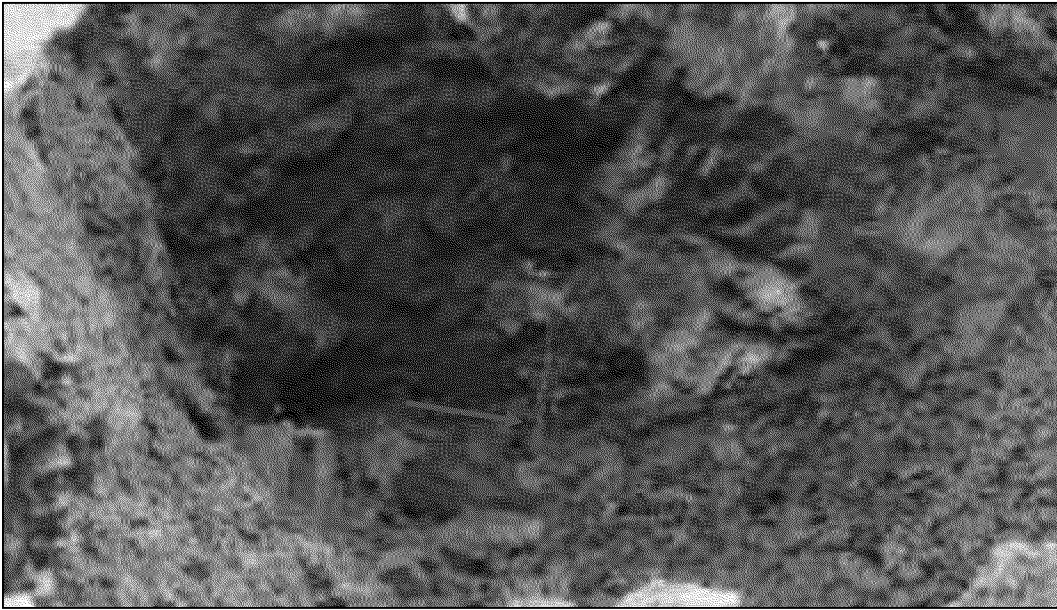
Figure 49.—A cropped and enlarged version of a portion of the photograph taken at 10:51 a.m. on August 5, 2015 (figure 48). Red arrow points to the initial vertical spurt of clear water shooting up about 1.5 to 2 feet as described by the EPA OSC (photograph from EPA project files).

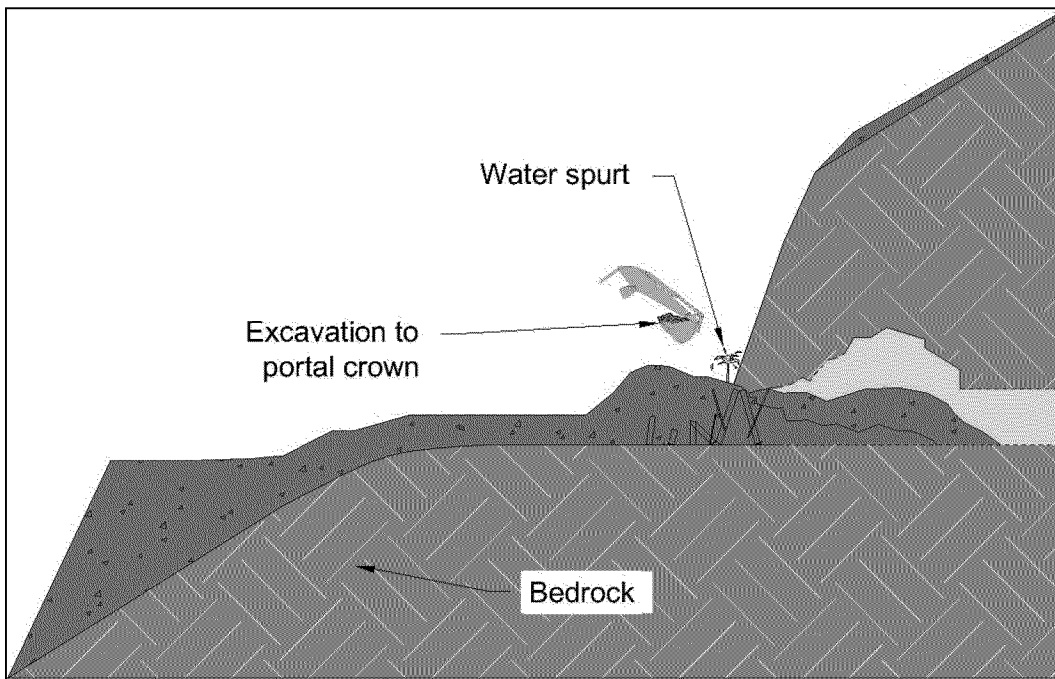
Figure 50.—Cross-section showing BOR's interpretation of the conditions immediately before the blowout as the spurt of water appeared indicating the adit was full and under pressure (not to scale).
